Manhole Inspection Summary

Manhole # S09AA2008MH

Insp Date: **9/18/06 9:56 AM**

Location Address: **5800 STUART AVE**

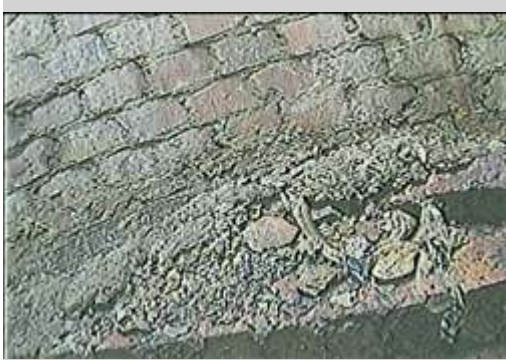
Bench ☒ Exists Material: **Brick** ☐ Parged ☒ **Debris** (not Condition related)

Bench debris and Barrel infiltration.

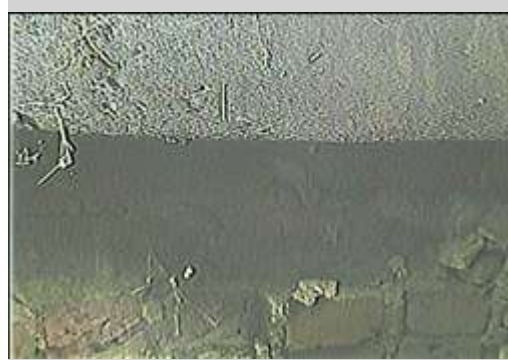
Defect

Frame Offset: **0** (in.) Condition: ☐ Sound ☐ Cracked ☒ **Leaks**

Condition: ☐ Sound ☐ Cracked ☐ Root Intrusion ☒ **Loose Brick** ☒ **Deteriorated**

Infiltration: ☐ None ☒ **Joint** ☐ Cracks ☒ **Mortar** ☐ Roots ☐ Wall

Frame leaks. Adjustment deterioration.
Adjustment infiltration.

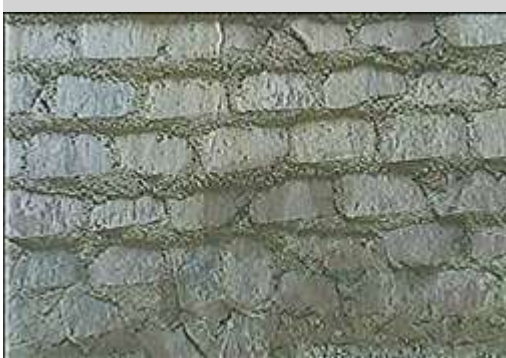
Defect

Infiltration: ☐ None ☒ **Joint** ☐ Cracks ☒ **Mortar** ☐ Roots ☐ Wall

Barrel infiltration.

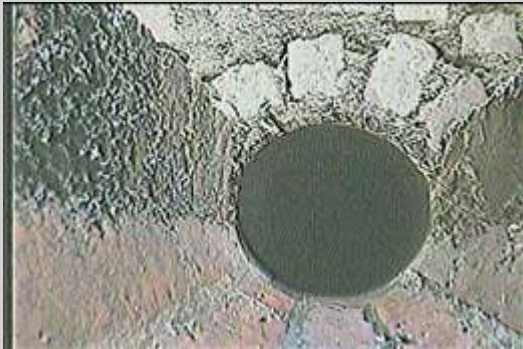
8 in. Circular Gravity Sewer Pipe Out @ 12 O'Clock

Infiltration: **Evidence** Pipe Seal Cond: **Cracked**
